# RACING TIP #2

November, 2004

## 2005 440 IQ and IQ Rolling Chassis Rear Track shock information

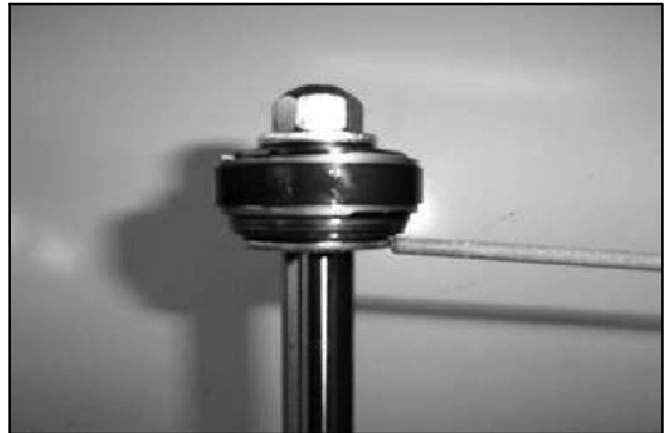
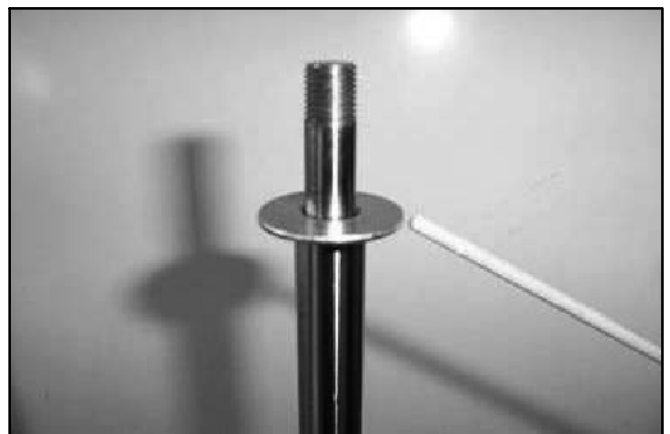
The 1.25" x .090" steel top out washer found on the compression stack valving may be installed incorrectly. Riding the vehicle **WILL DAMAGE** the upper rear track shock mounting bracket on the rear torque arm. Remove and disassemble the rear track shock as per the instructions in chapter 9 of the 2005 440 IQ service manual (PN 9919307).

After removing the valve stacks carefully inspect the orientation of the 1.25" x .090" (shown in images below) steel top out washer on the shock shaft. This washer is not flat. It should be placed with the convex surface facing the shim stack and the concave surface facing the flat of the shock shaft. After verifying the washer is correct reassemble the shock as outlined in chapter 9 of the 440 IQ service manual..
